U.S.S. MONITOR

A FINAL REPORT
ON 1979 SITE TESTING IN THE MONITOR NATIONAL MARINE SANCTUARY

BY GORDON P. WATTS, JR.
NORTH CAROLINA DEPARTMENT OF CULTURAL RESOURCES

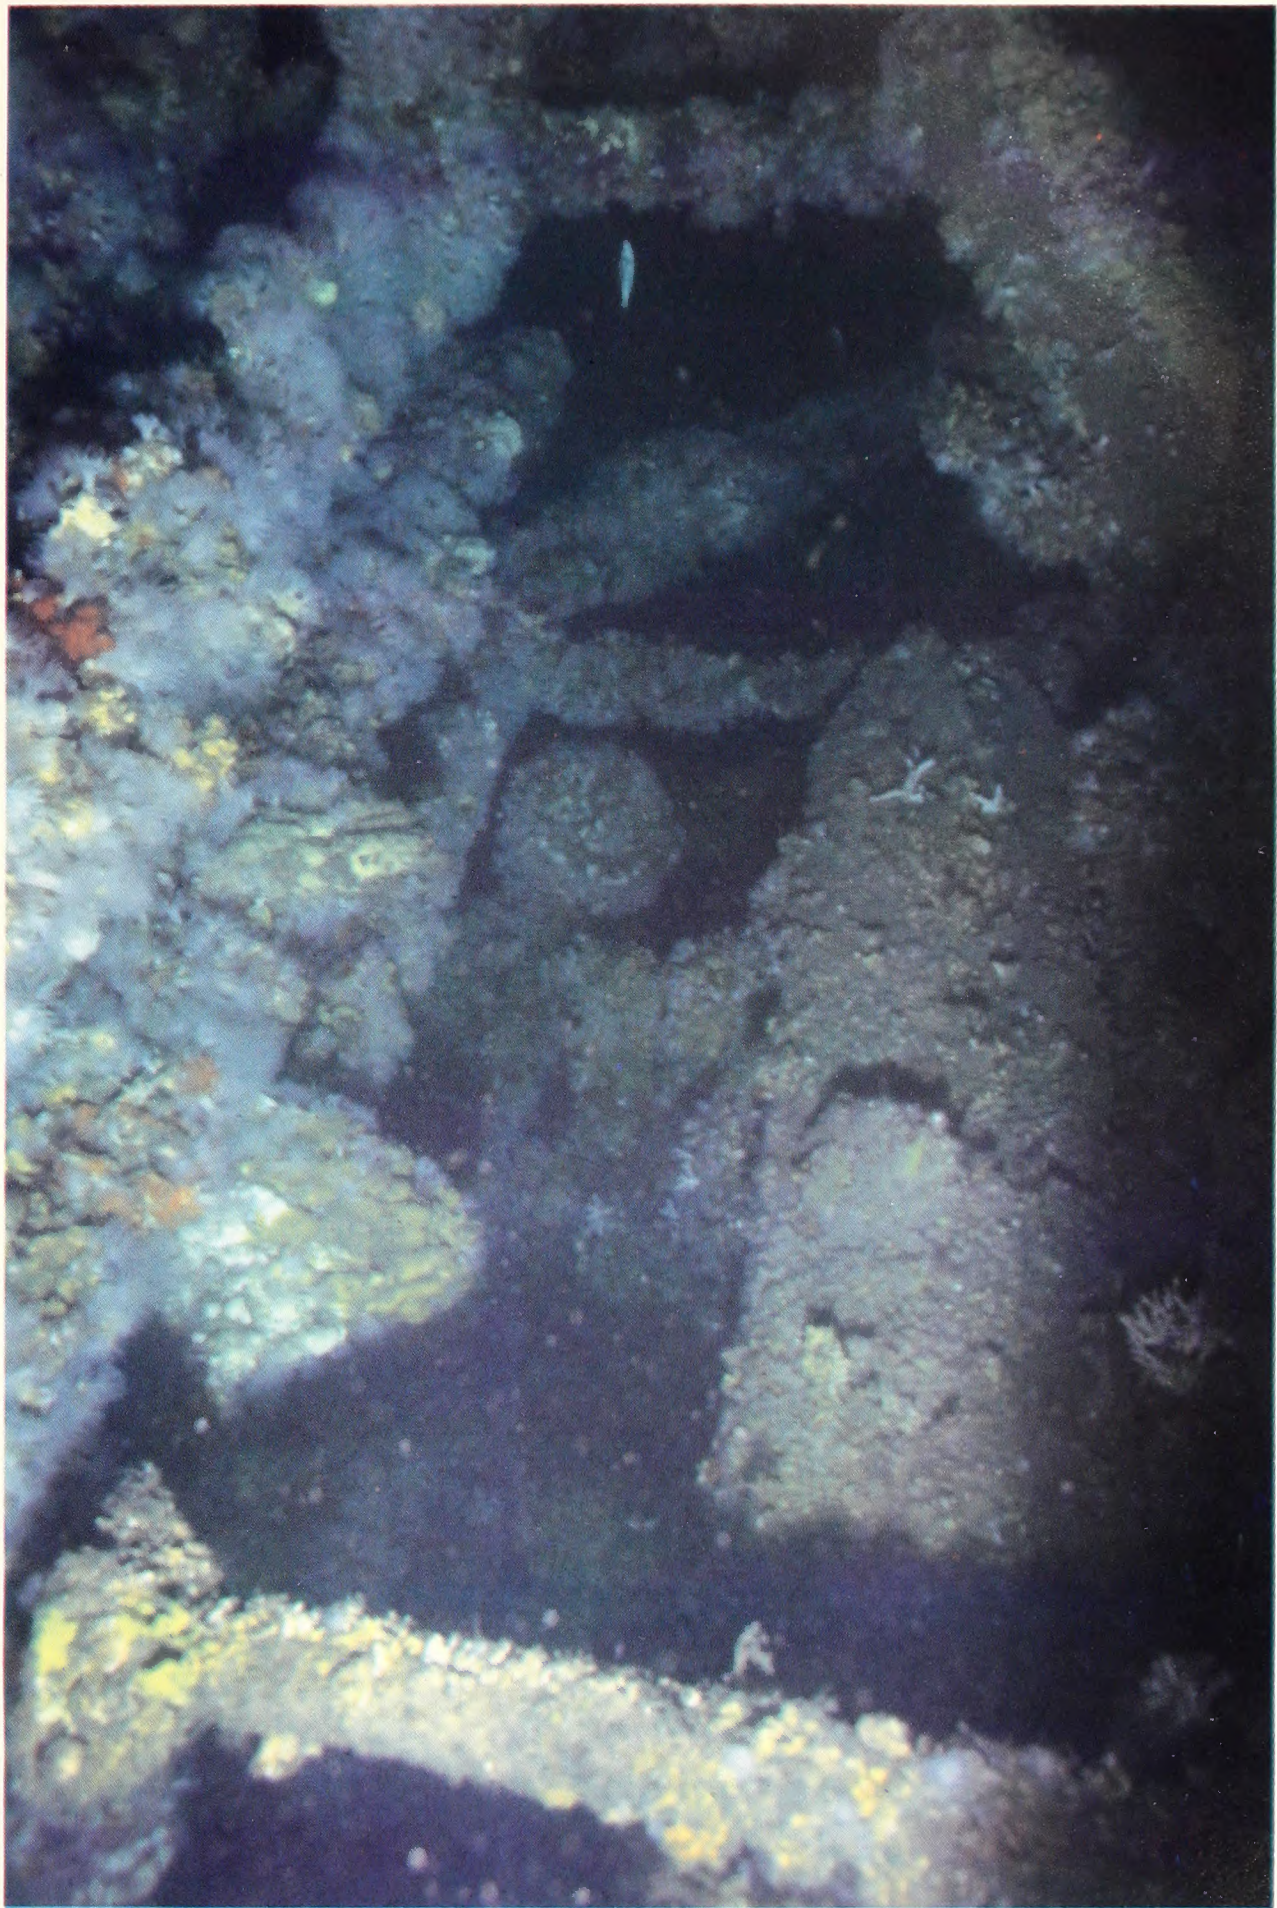
Both port and starboard boilers were found to be intact and in excellent condition (*Figure 120*). Although they appeared to have separated from the foundations, rupturing some of the piping, no evidence of forward or aft movement was apparent. Inspection plates, firebox doors, and access to ash pits were all found open, making an examination of the fire tubes possible (*Figure 121*). The uptake on the after-end of the port boiler was found to be partially detached as a result of shifting of the structure. Inboard of both the port and starboard armor belts coal from deteriorated bunkers located adjacent to the boilers was found to obstruct passage from the galley to the engineering space aft of the boilers (*Figure 122*).

Figure 120. Looking aft from the galley over the bottom of the starboard boiler, heavily-fouled floors at the top of the photograph remain secured to stanchions visible at the right.

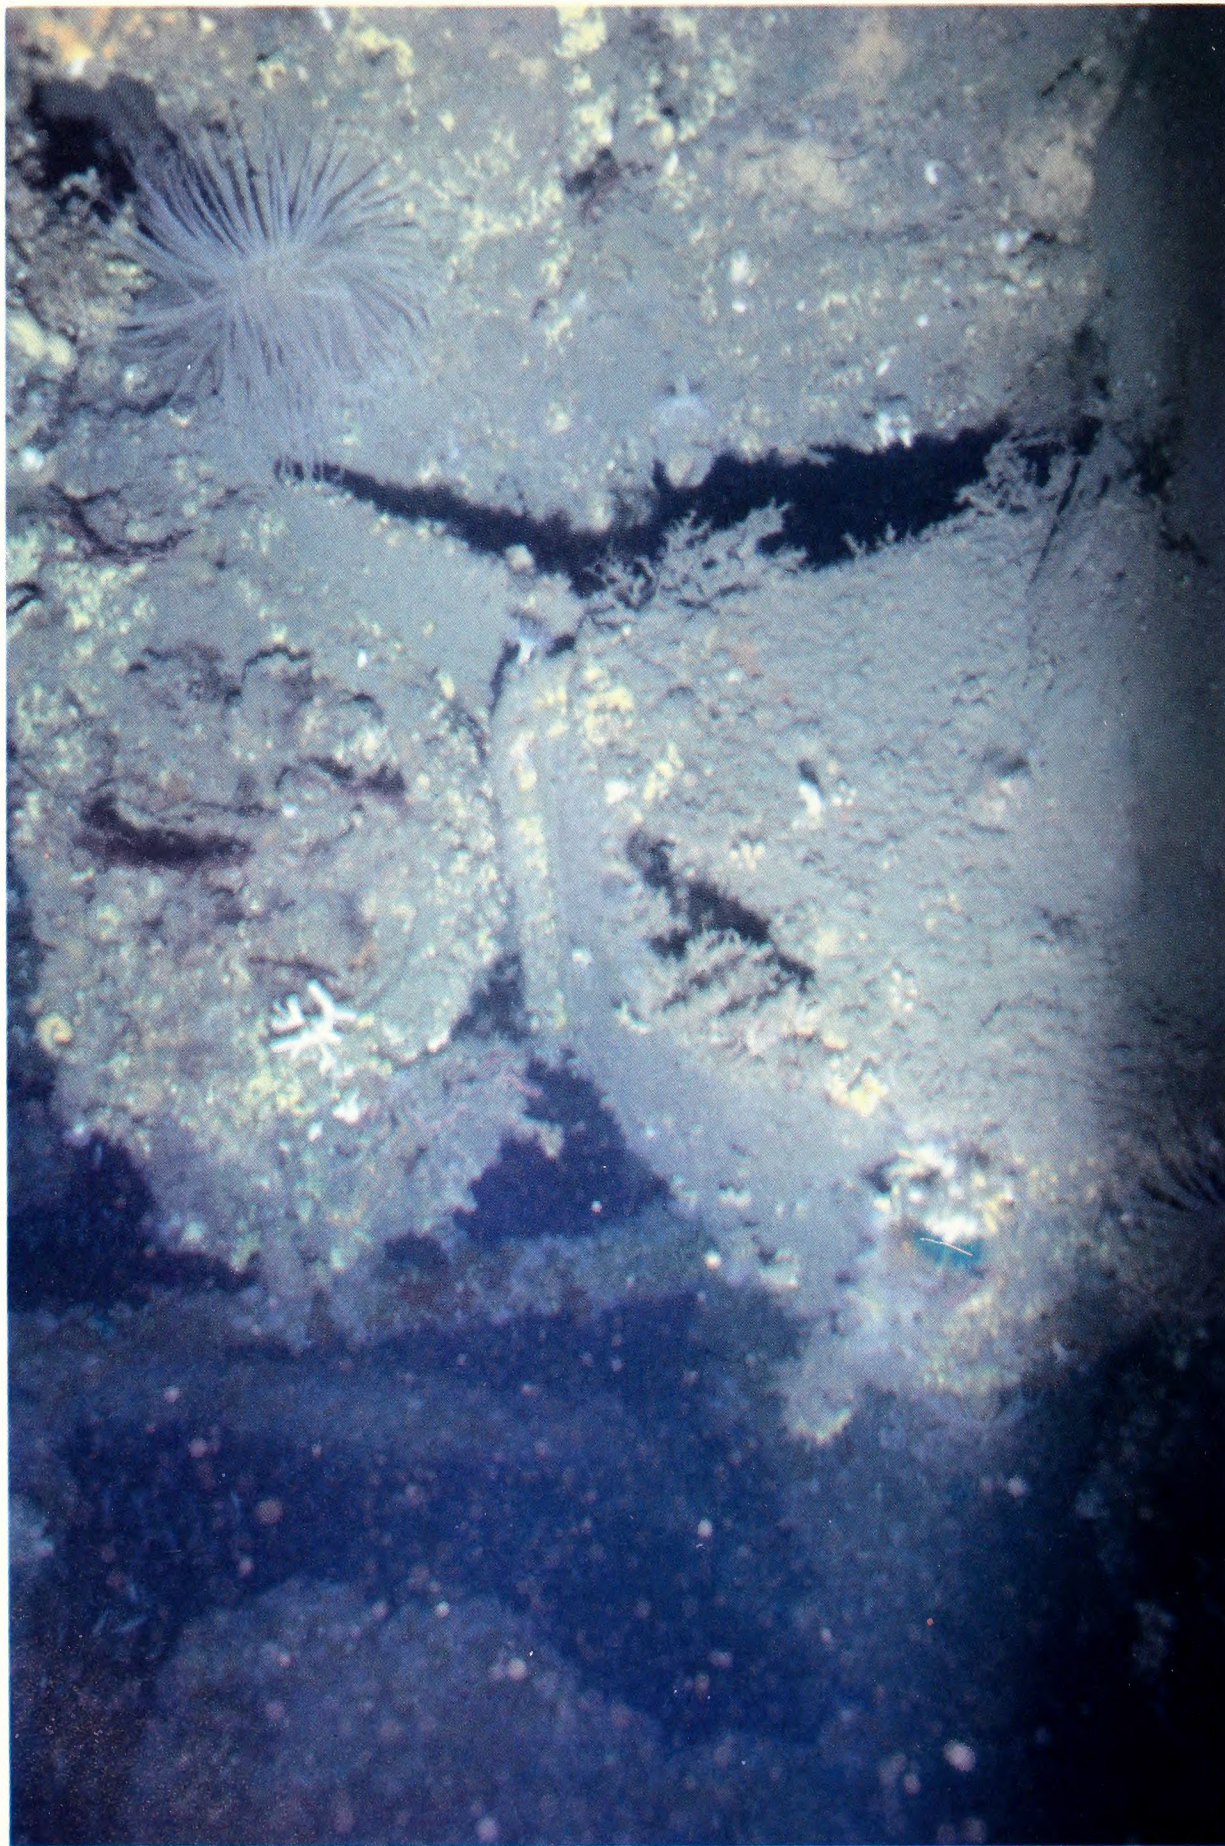
Figure 121. The starboard boiler exhaust uptake rests approximately in its original position, although no longer attached to the afterface of the boiler. Above the duct an encrusted furnace door hangs from its hinges.

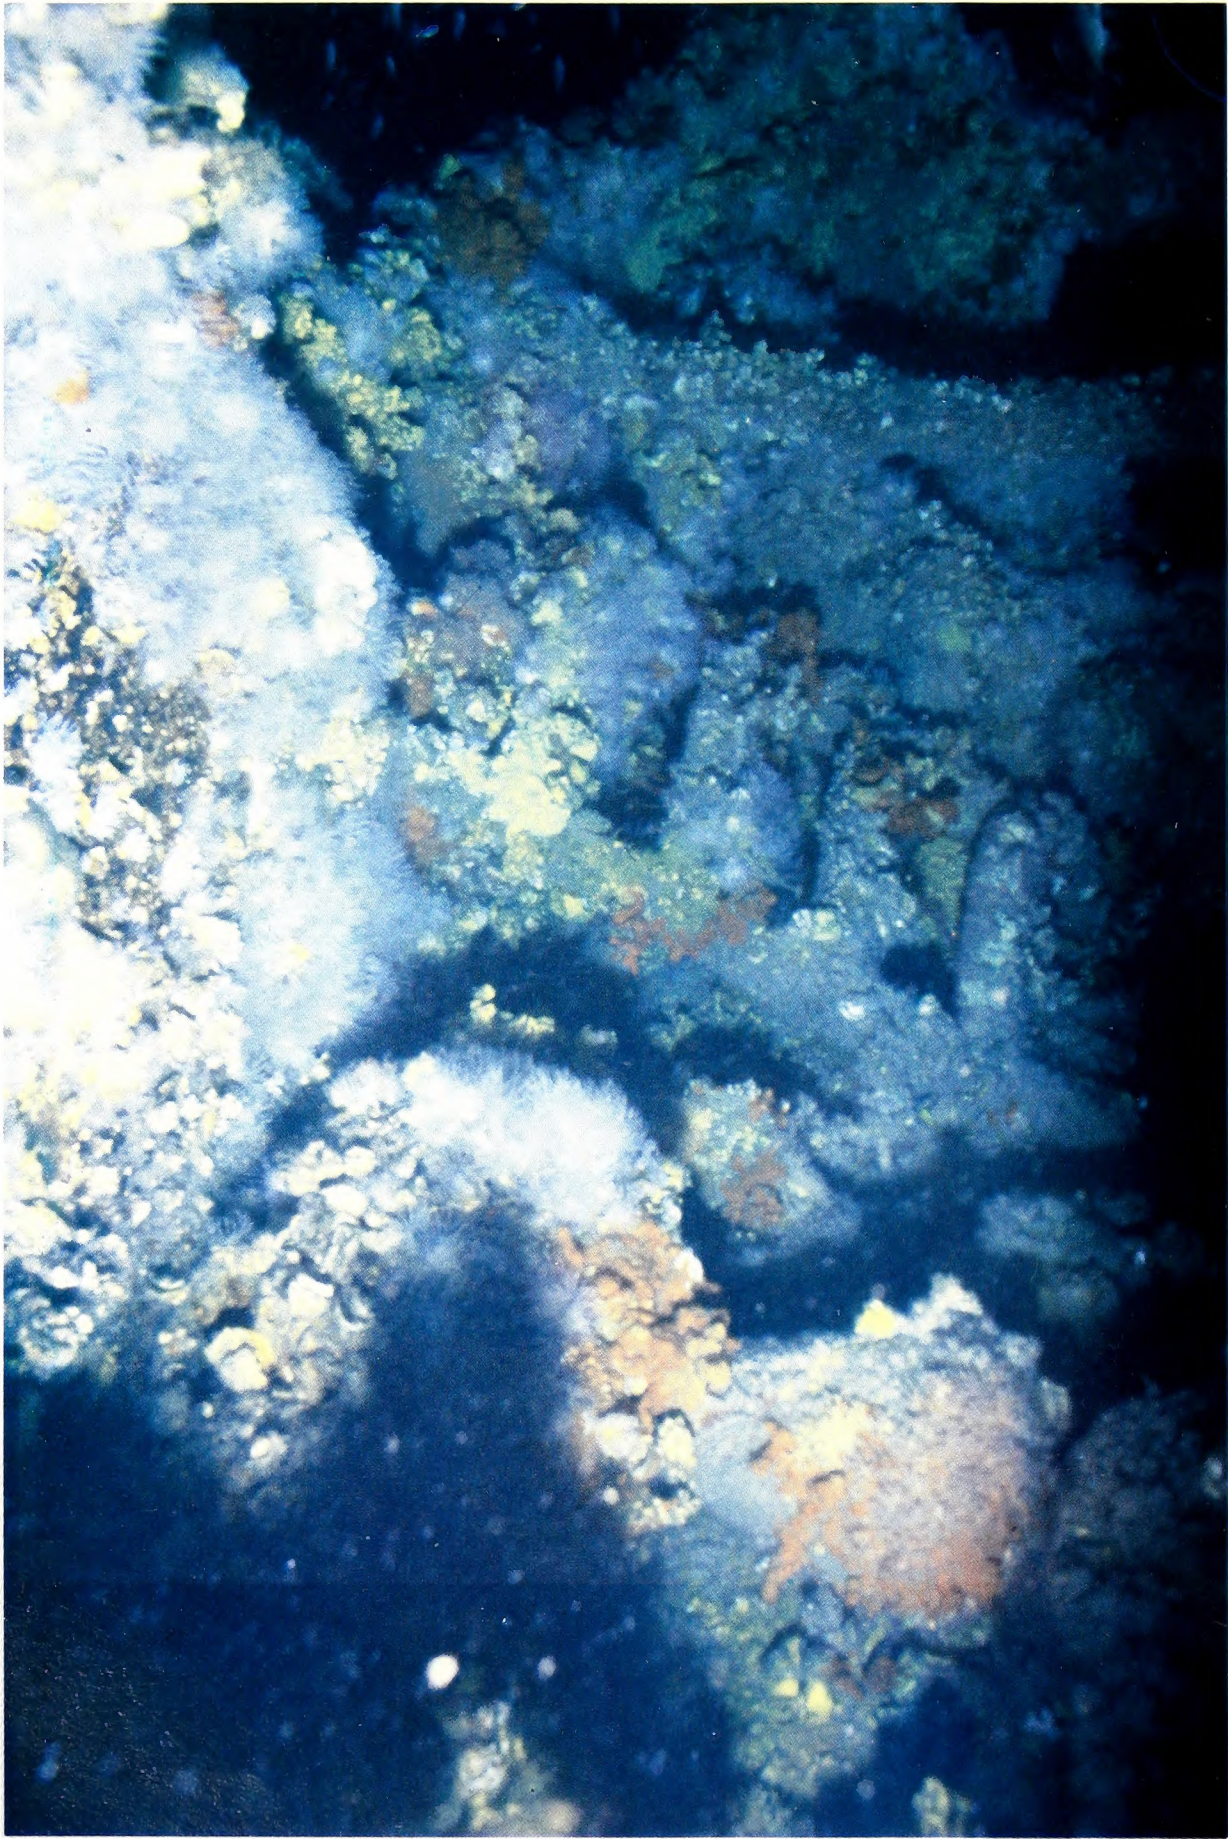
Figure 125. To starboard of the air chamber of one of two Worthington pumps located immediately forward of the steam machinery (bottom right) a stairway leads from the engineering space deck to a platform that supported the engines. Aft and to starboard of the stairway, a second blower and associated steam engine remains intact.

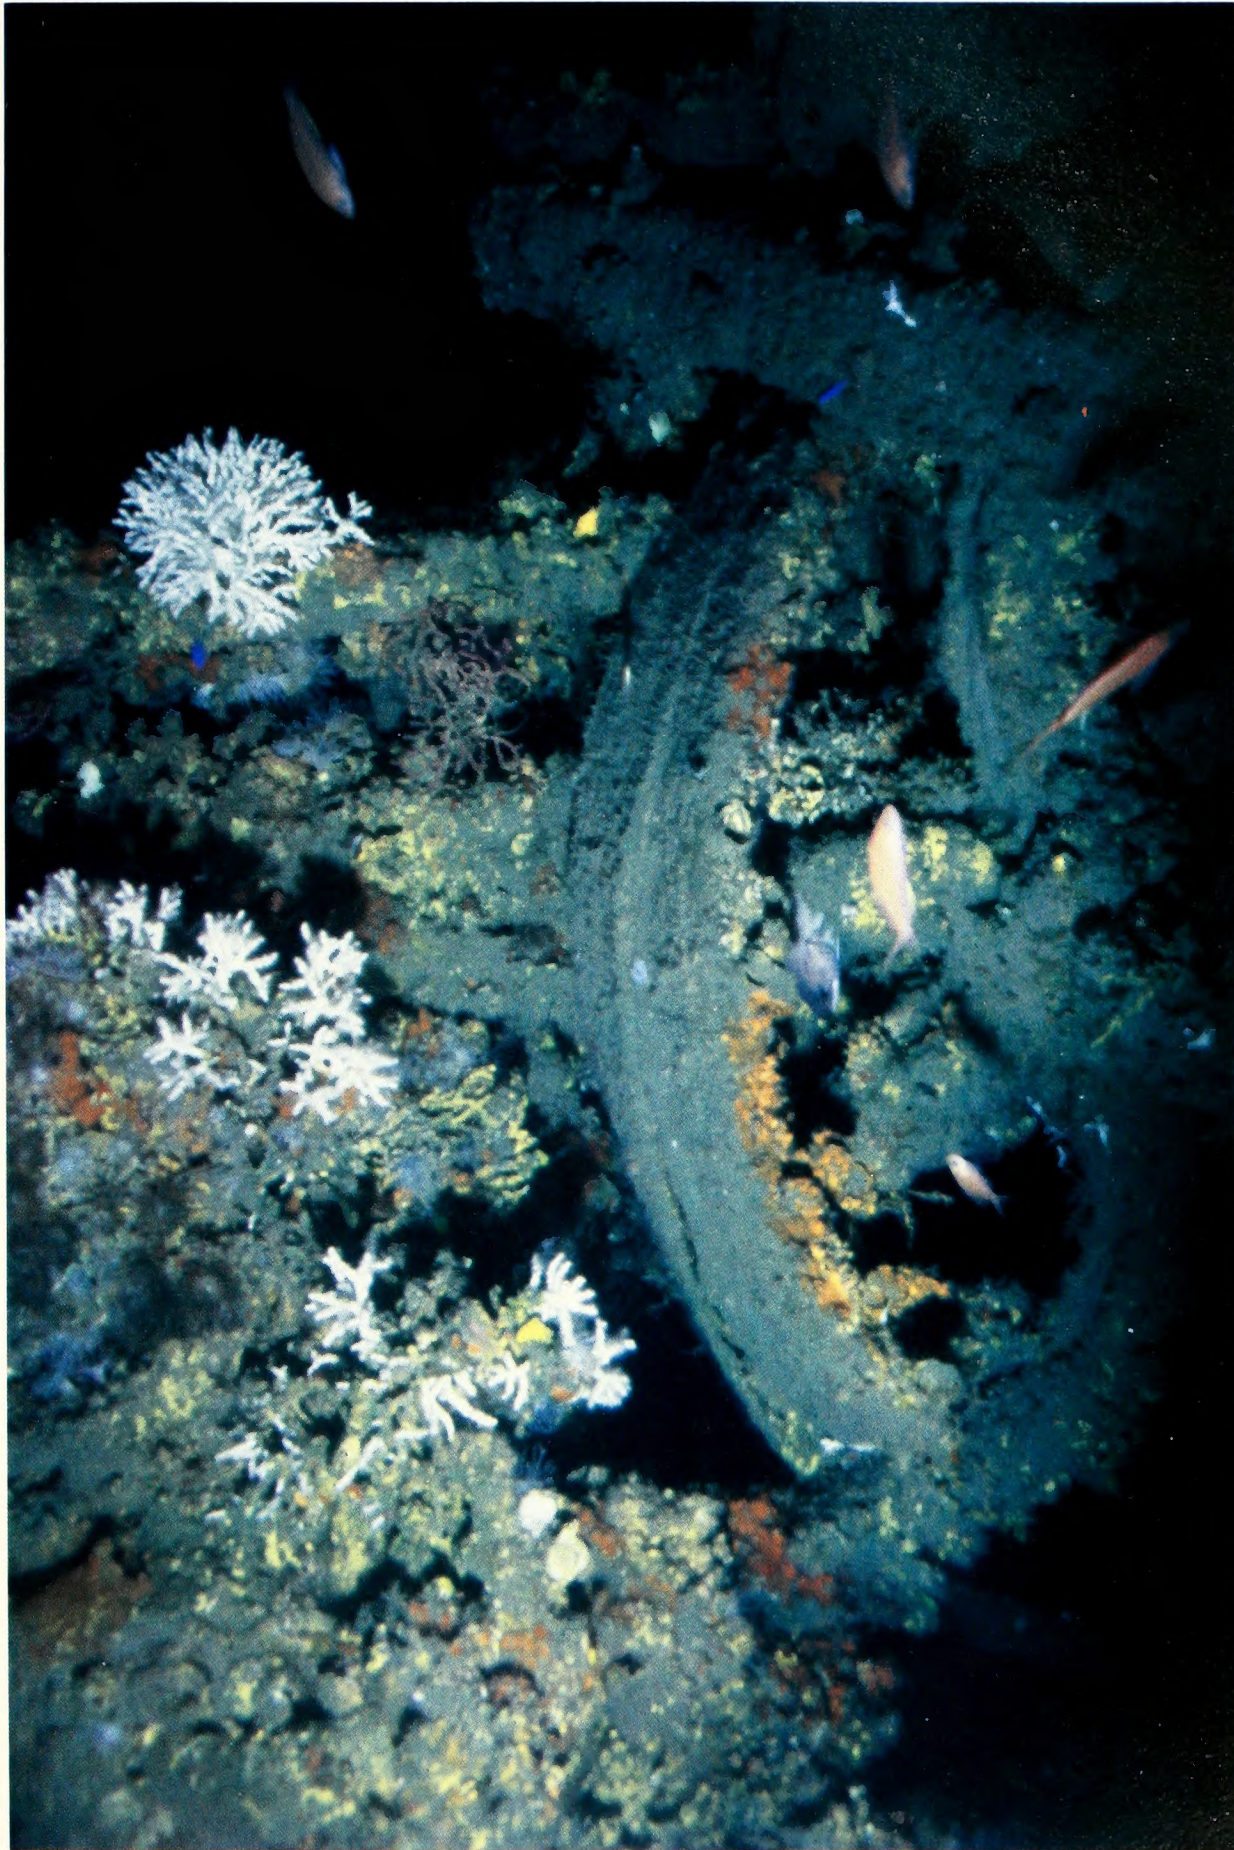
Figure 126. The heavily-concreted flywheel of the port ventilator donkey engine with leather belt intact lies just inside the armor belt in the lower hull engineering space.

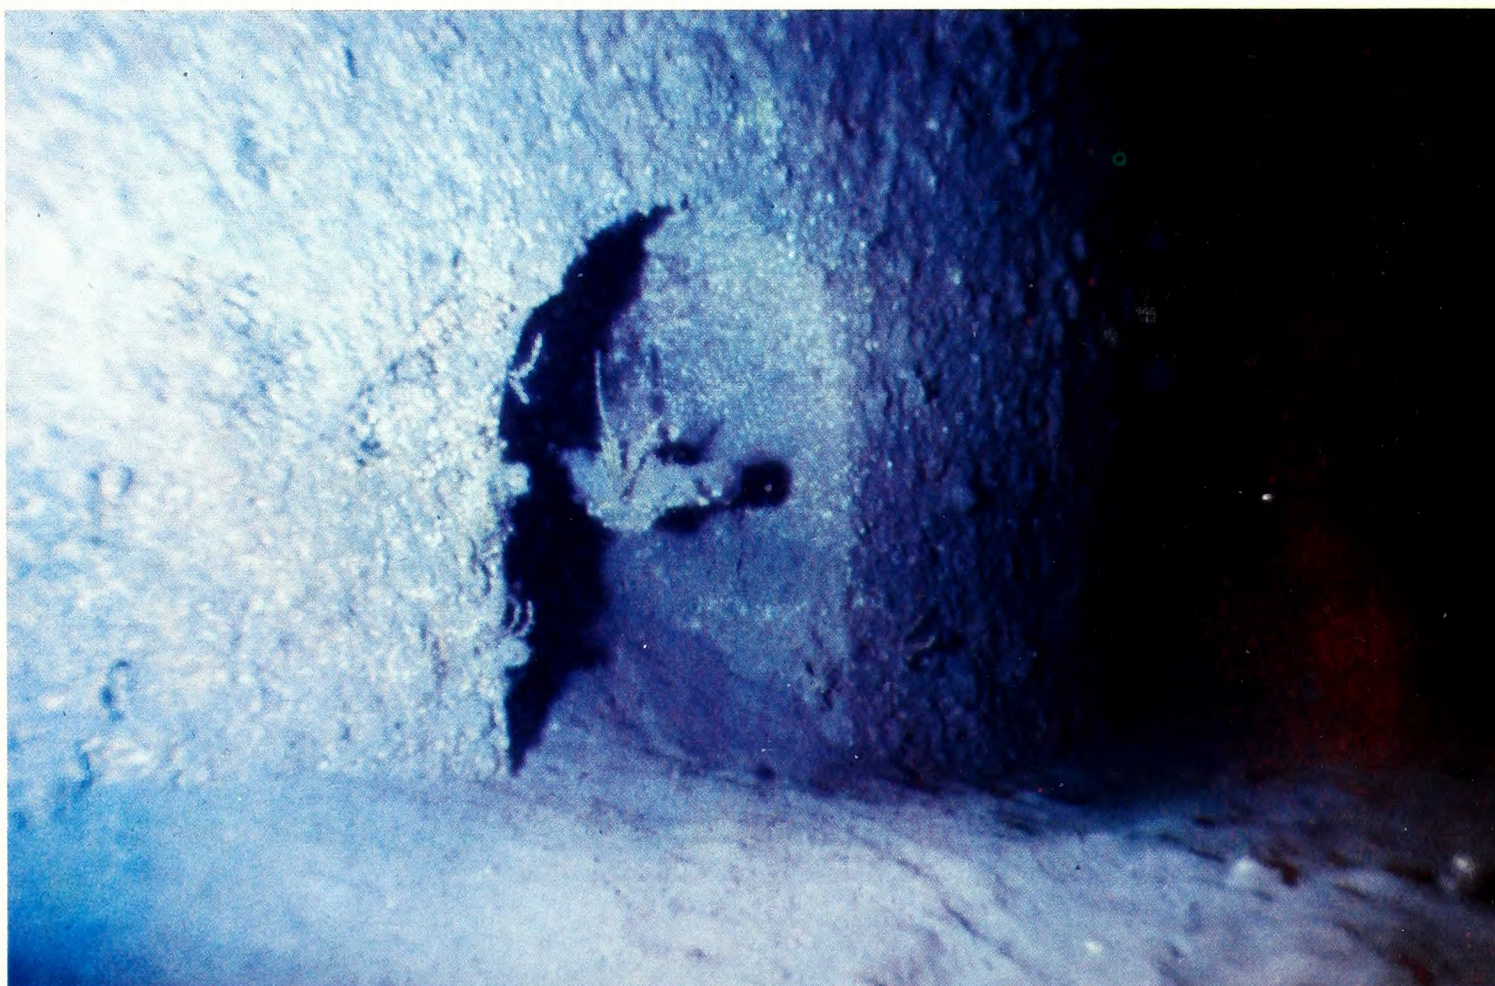
In the vicinity of the turret deck plates were found to have been dislodged by destruction associated with the stern of the vessel. Behind the turret the deck was, in fact, found to have completely separated and armor plates hung suspended by deteriorated fittings (*Figure 129*). Forward of the turret deck armor plates were generally in their original position and disturbance was slight. Below the position of the port boiler the uptake was found protruding from the deck and into the sediment.

Figure 129. Beyond the turret, armor plates from the damaged after-deck of the Monitor were found to have separated from their fastenings and collapsed onto the sediment. Shafts protruding from the gun ports (starboard top and port bottom) were used to secure wood gun port bucklers (covers) to heavy wrought iron pendulums inside the turret while the ship was underway.

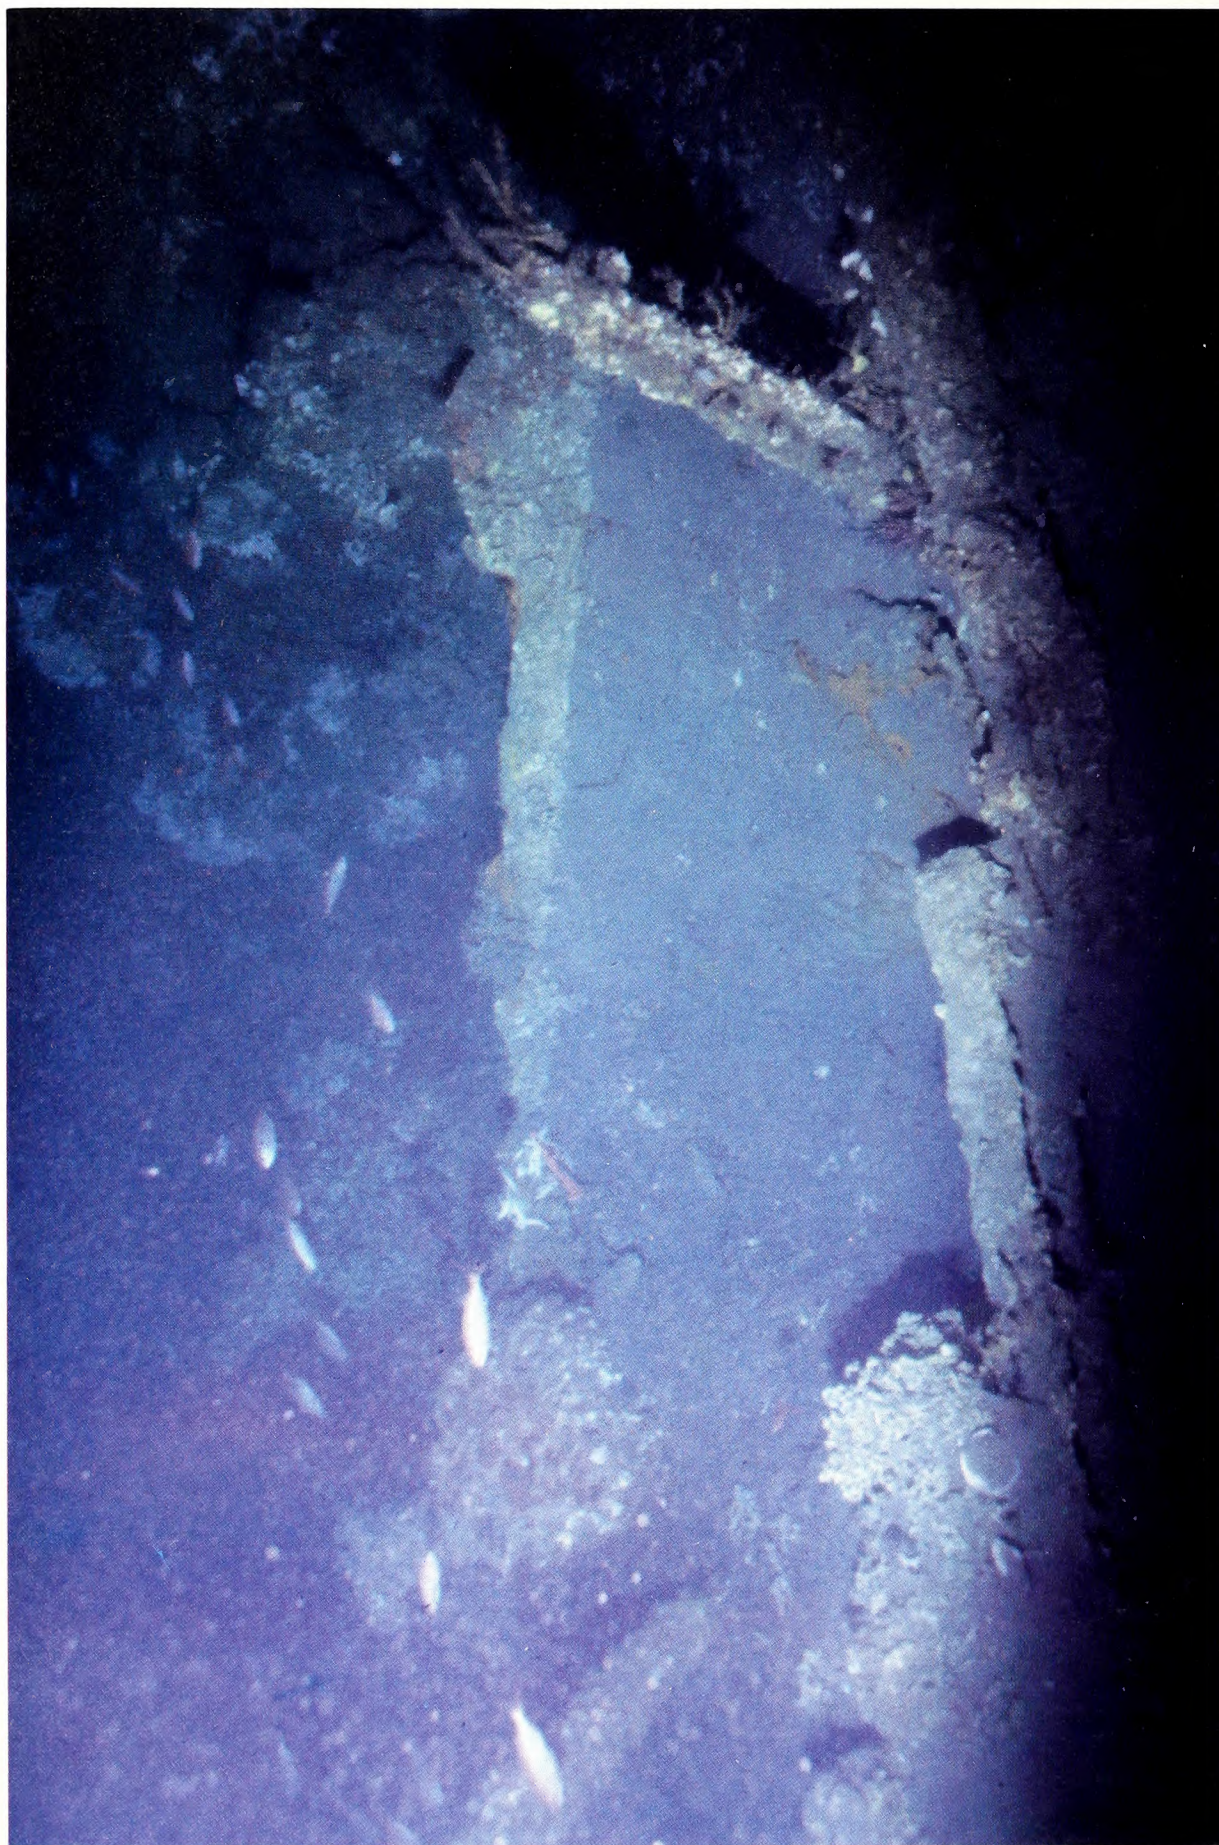
Figure 130. The location of the test excavation was inboard of the port armor belt and aft of an iron bulkhead that separated the captain's quarters from the chain locker.
